CONNECTICUT RIVER BASIN
SOUTH HADLEY, MASSACHUSETTS

HILLSIDE BEACH
MA 00600

PHASE I INSPECTION REPORT
NATIONAL DAM INSPECTION PROGRAM

JUNE 1979

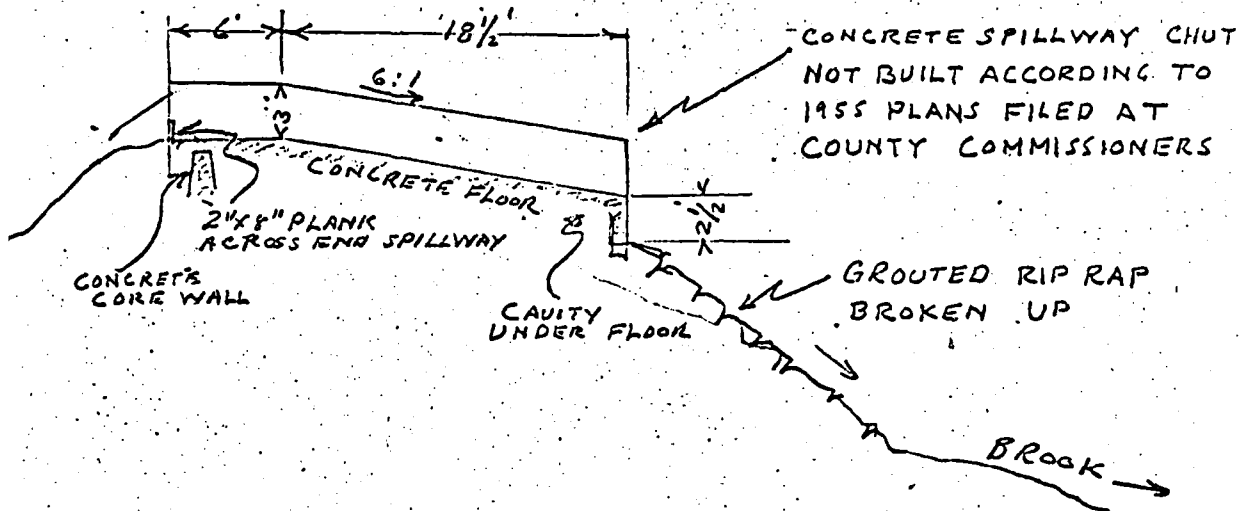
XX SECTION "BB"

Overflow spillway at the left end of the embankment was found to be satisfactory. However, embankment repairs are needed adjacent to the side walls of the spillway structure. This dam has received no maintenance over the past two years.

Owner should be advised to properly maintain the dam by doing the work recommended hereinbefore.

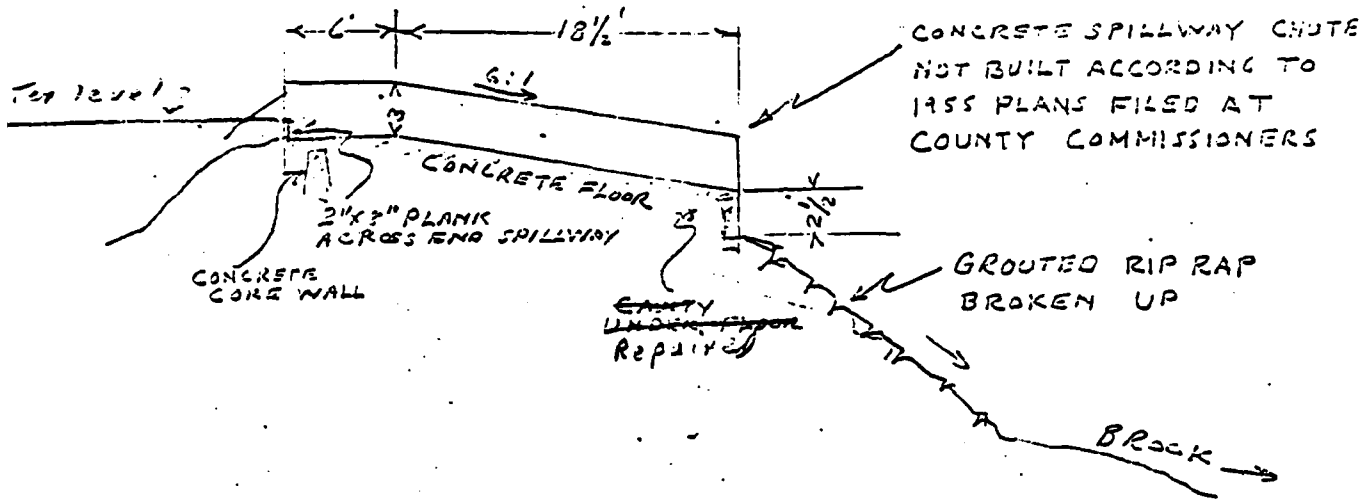
XX SECTION "BB"

Comments: Cover of brush and brambles so thick slope could not be examined fully.

Slope irregular. There is a washed area along side of emergency chute spillway
